**NASA
Technical
Paper
2520**

Abrasion Behavior of Aluminum
and Composite Skin Coupons,
Stiffened Skins, and Stiffened
Panels Representative of
Transport Airplane Structures

Karen E. Jackson

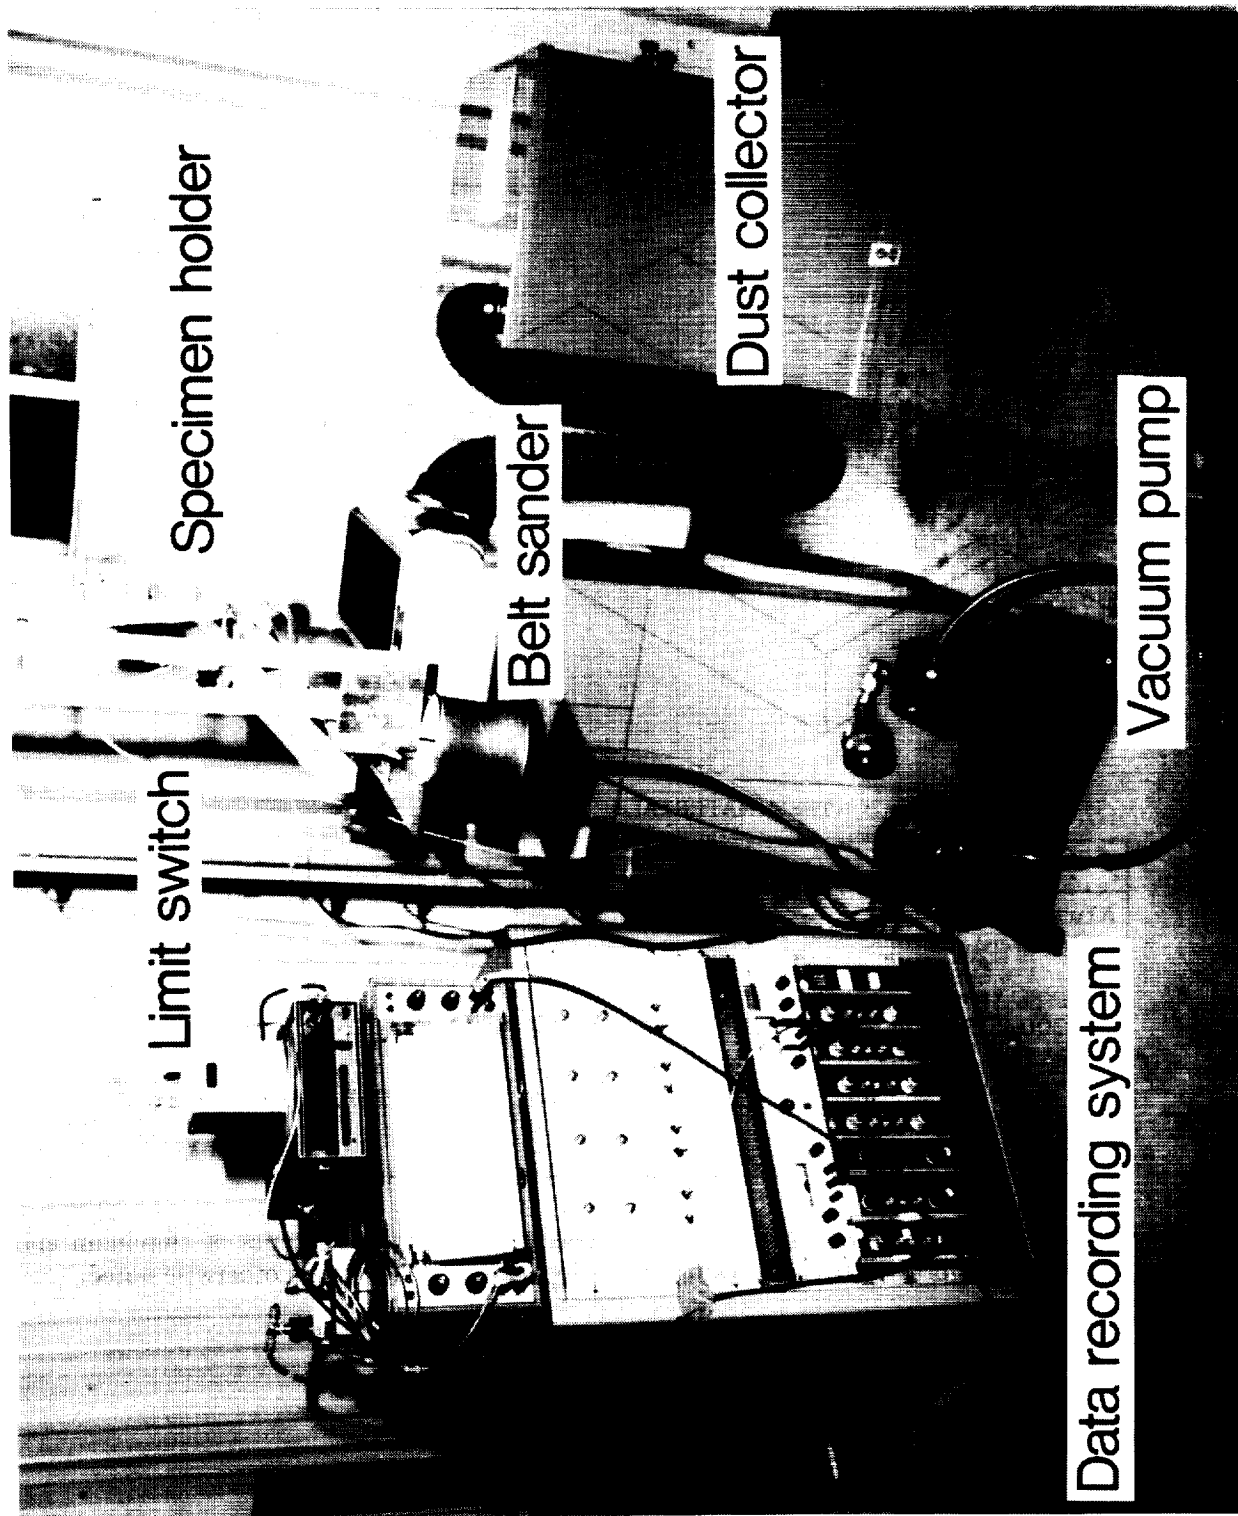
Figure 2. Abrasion test apparatus for skin-coupon tests.

Apparatus. The apparatus used to perform the skin-coupon tests is shown in figures 2 and 3. A belt sander fitted with a 6-in. by 48-in. aluminum

oxide belt provided the sliding, abrasive surface. Skin-coupon test specimens were held in place by a specimen holder which was attached to the belt sander by a parallelogram arrangement of mechanical linkages. The linkages were pivoted about a back upright such that the specimen holder could be raised and lowered parallel to the abrading surface. The skin coupons fitted into a recess in the specimen holder and were held securely in place by a vacuum created behind the specimen by the vacuum pump (fig. 2).

The test apparatus was also instrumented with a limit switch (fig. 2). The limit switch triggered an event marker on the strip-chart recorder when the test specimen was lowered to the abrading surface at the start of a test run. When the run was complete, the test specimen was raised, the limit switch was released, and the event marker returned to its original position. The test run time was then determined by measuring the distance between the two event marks on the strip-chart recorder and dividing that value by the chart speed.

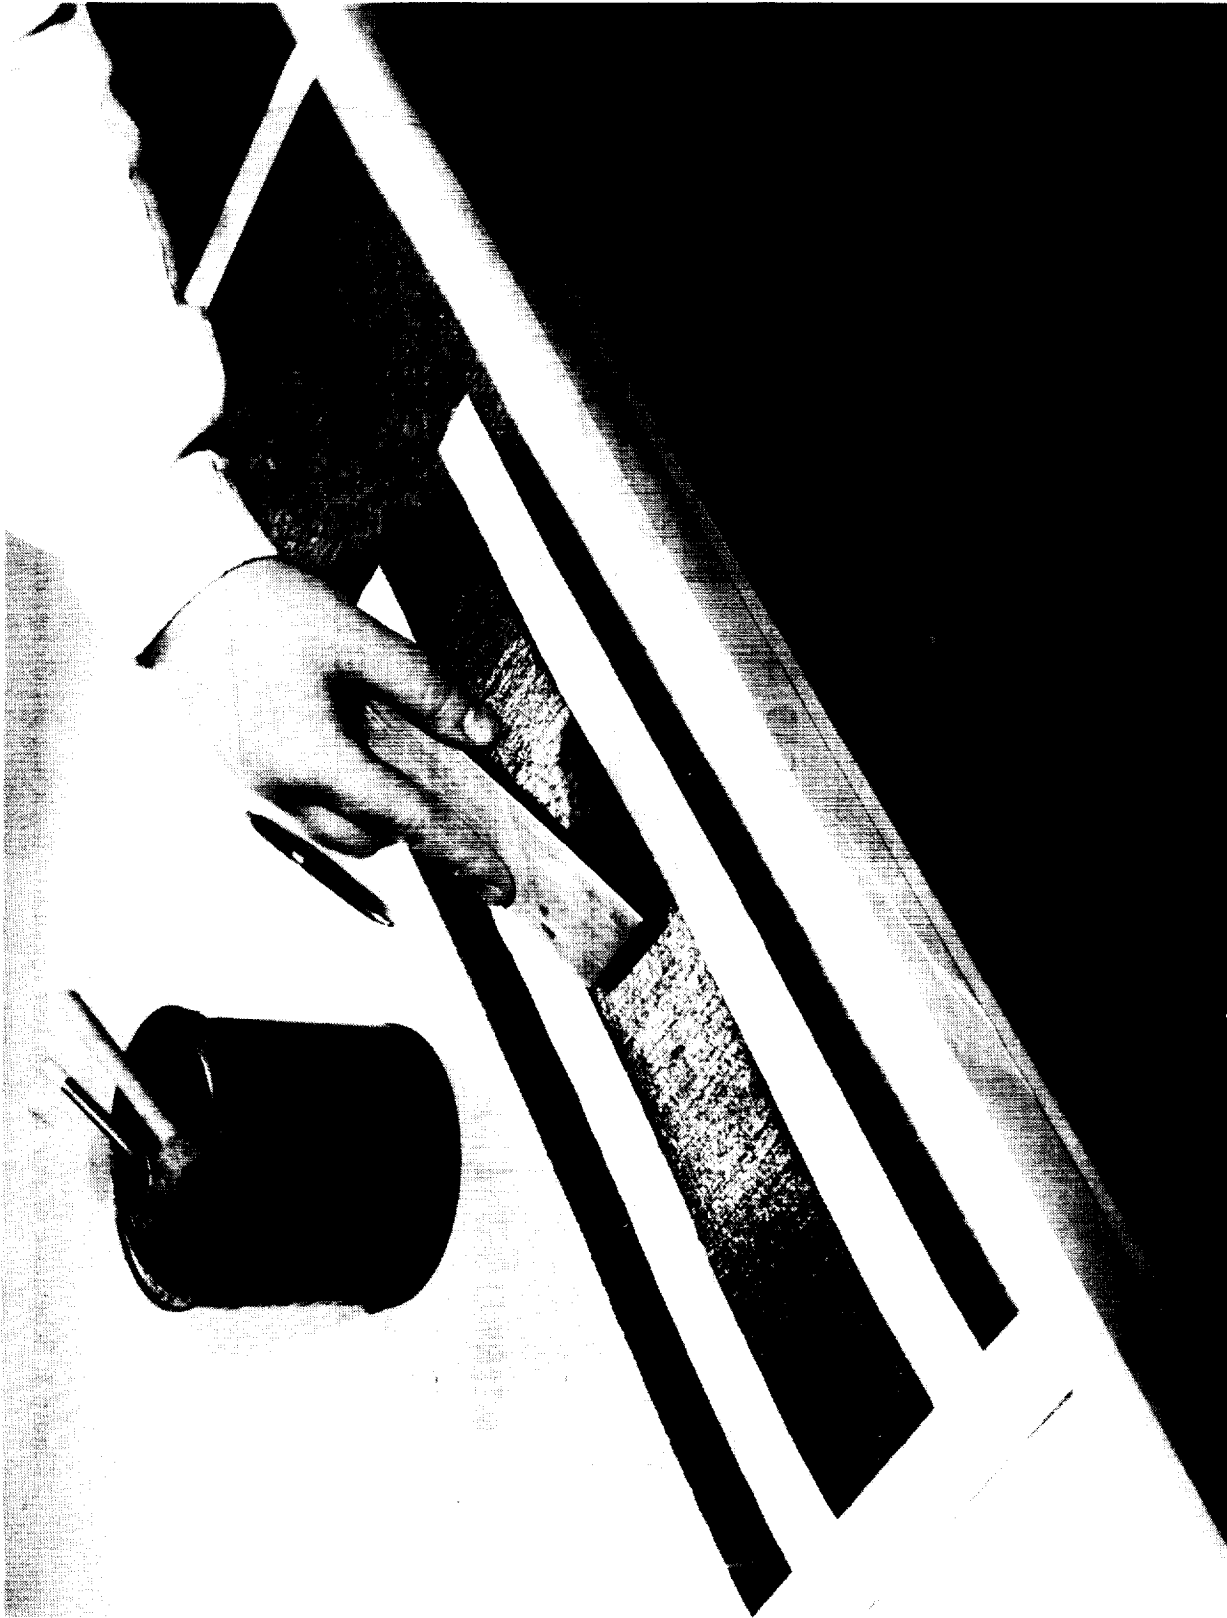
Figure 4. Illustration of grease sample technique to determine texture depth of aluminum oxide grit belts.

Standard 6-in. by 48-in. aluminum oxide belts with grit sizes ranging from No. 36 to No. 60 were used to simulate runway surfaces. This range of grit sizes was selected based on the average surface texture depths of these belts as measured with the grease sample technique (ref. 5), which has evolved as a method of classifying runway surfaces. This technique, illustrated in figure 4, involves marking a constant width on the surface to be tested and spreading a known volume of grease evenly within the marked region, filling the crevices and covering as much of the surface as possible. The volume of grease used divided by the surface area covered is the average surface texture depth.
